Dam ID: HI00098Alexander**Vulnerability Index:**

Date: 22 March 06

STATE OF HAWAII - DLNR
VISUAL DAM SAFETY INSPECTION SHEET

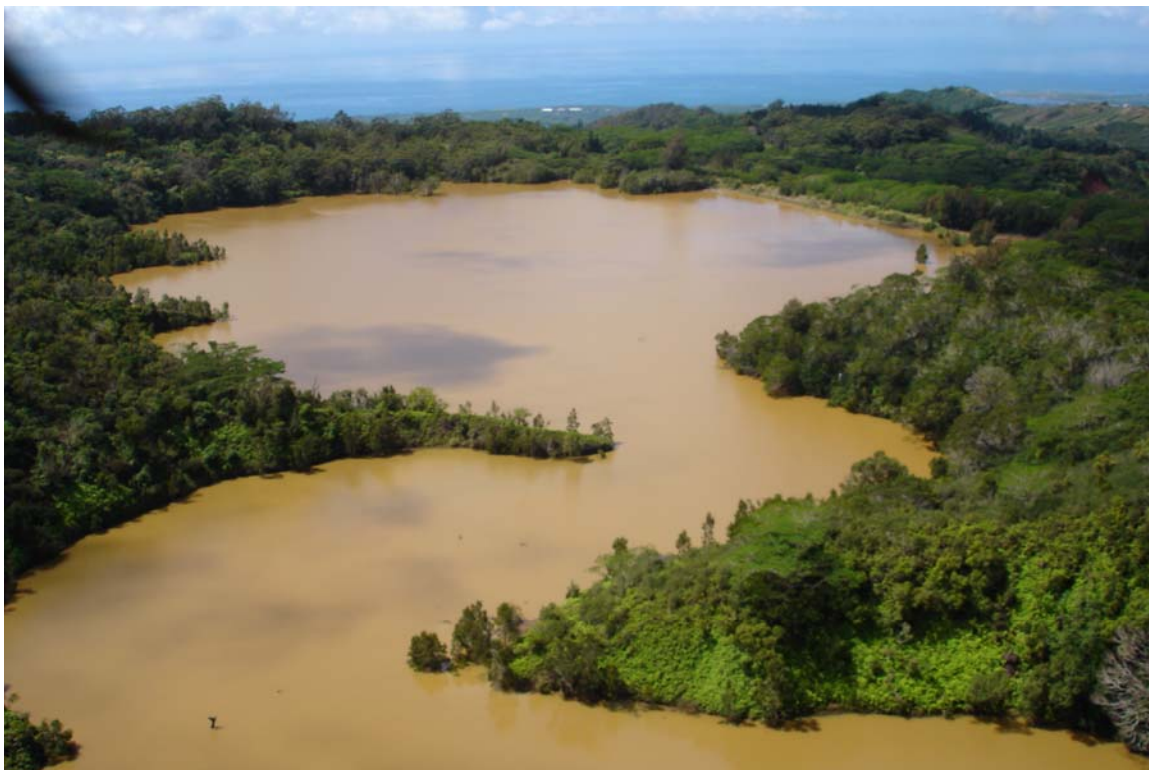
Photo of reservoir area. Dam and spillway located at top right corner of photo.

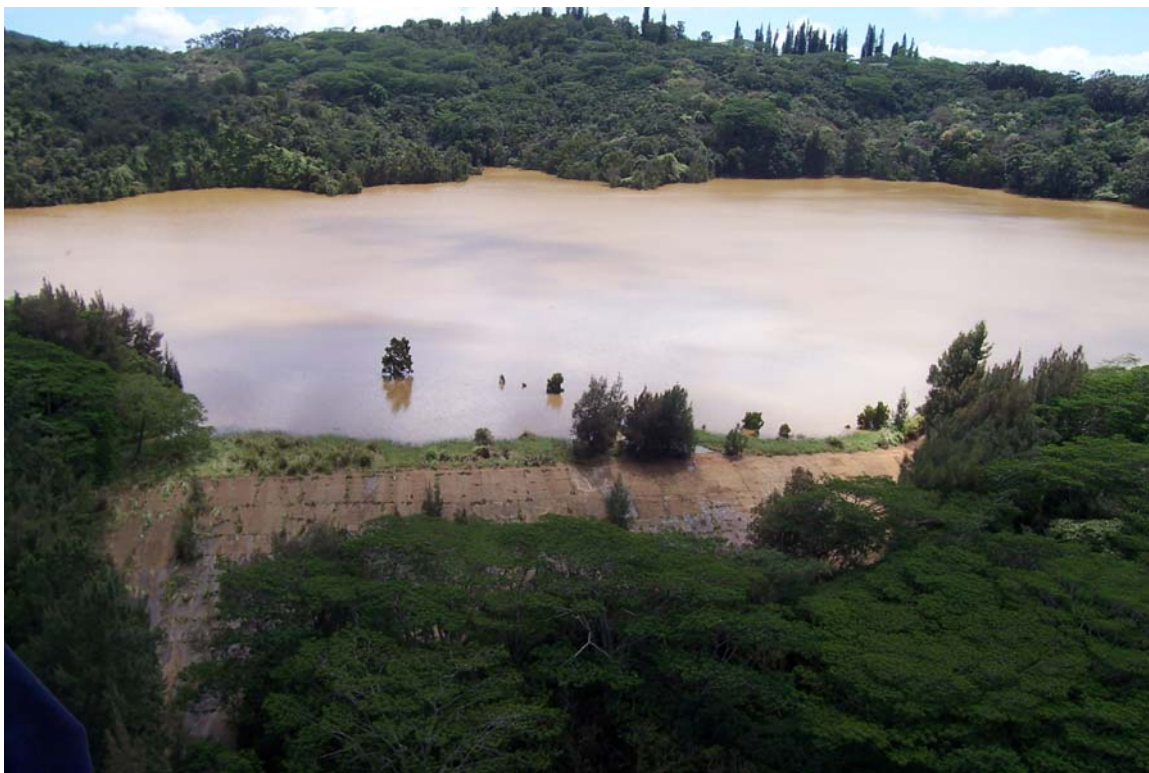
Aerial Photo of reservoir area and concrete chute spillway shown in bottom half of photo.

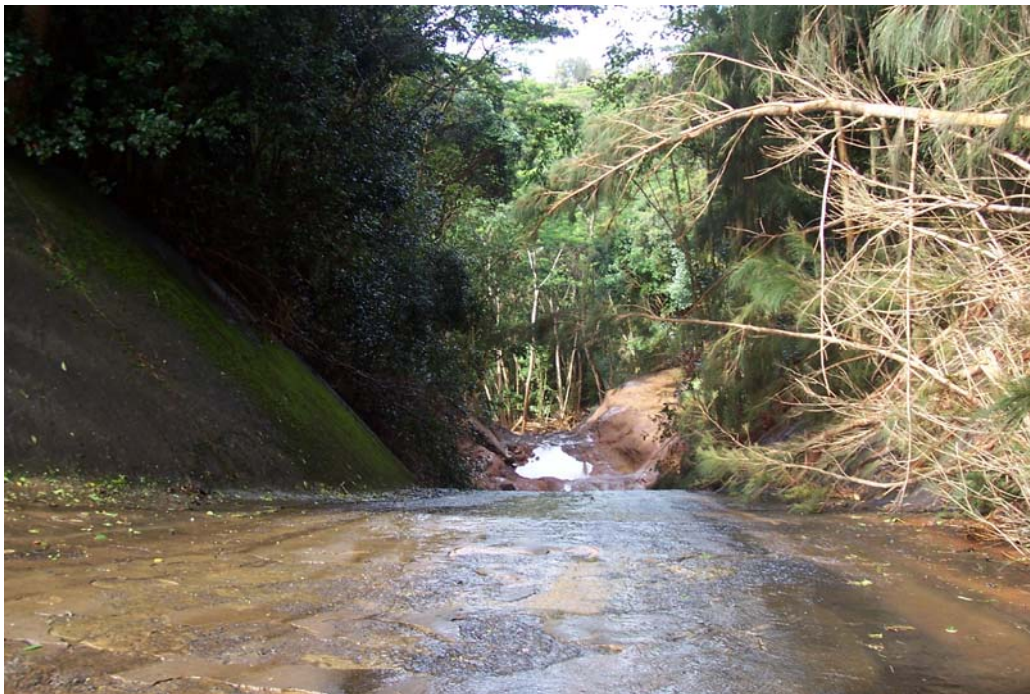
Photo taken from spillway crest looking downstream at discharge channel.

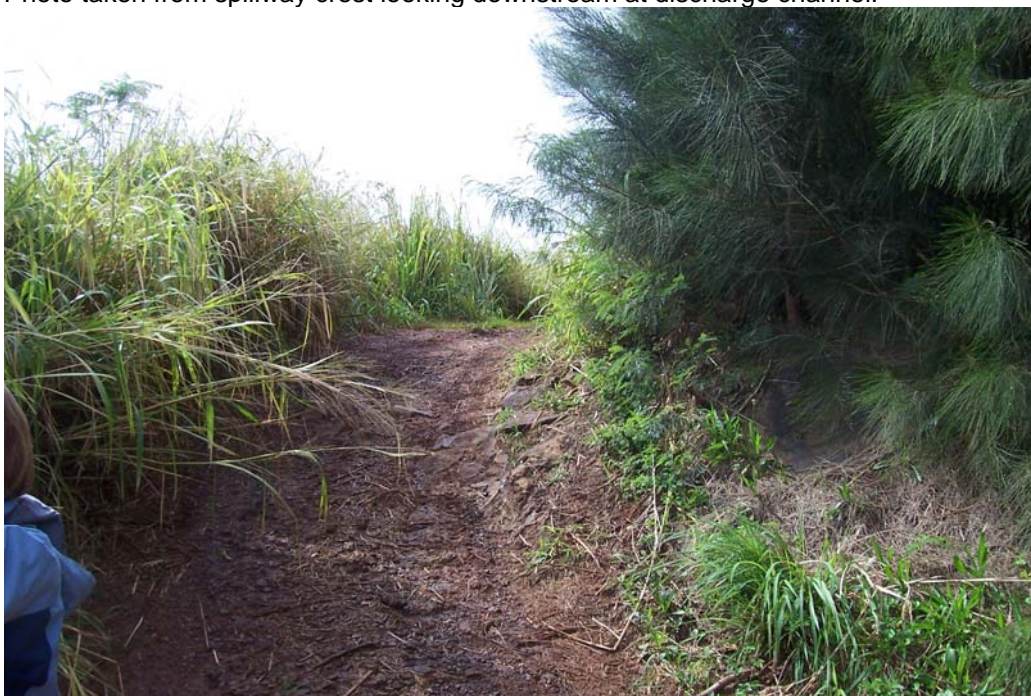
Photo taken of access road to dam crest from left abutment.

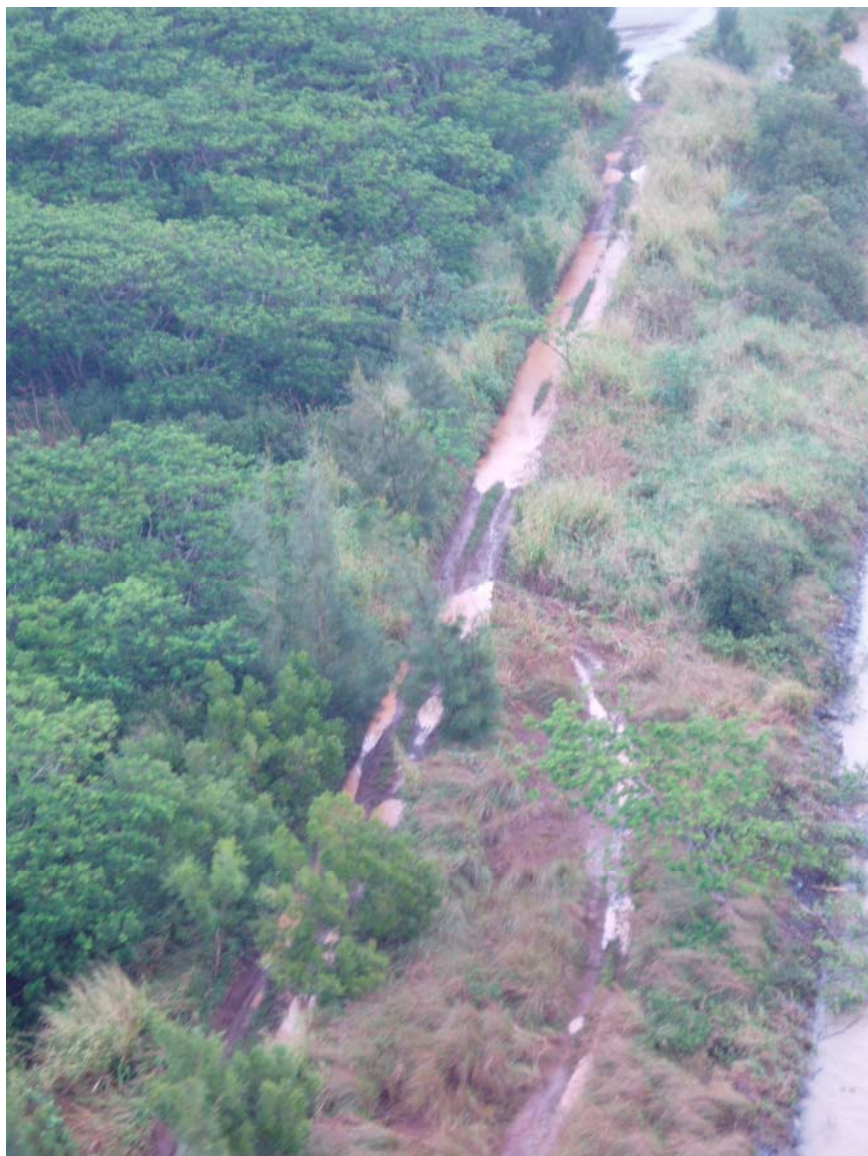
- . The slopes should be clear and visible for inspection. The existing trees have been allowed to grow so large in some cases that there is concern that seepage and piping (i.e. internal erosion) along root systems may develop. There is additional concern that cutting and killing the trees will lead to rotten roots and greater potential for such seepage and piping . A more in depth evaluation of the condition should be performed to determine how best to remediate the condition.

Aerial photo of dam crest (center), U/S (right) & D/S (left) slopes and spillway (top). Note extensive vegetation, including tall grass, brush, shrubs, and large trees.

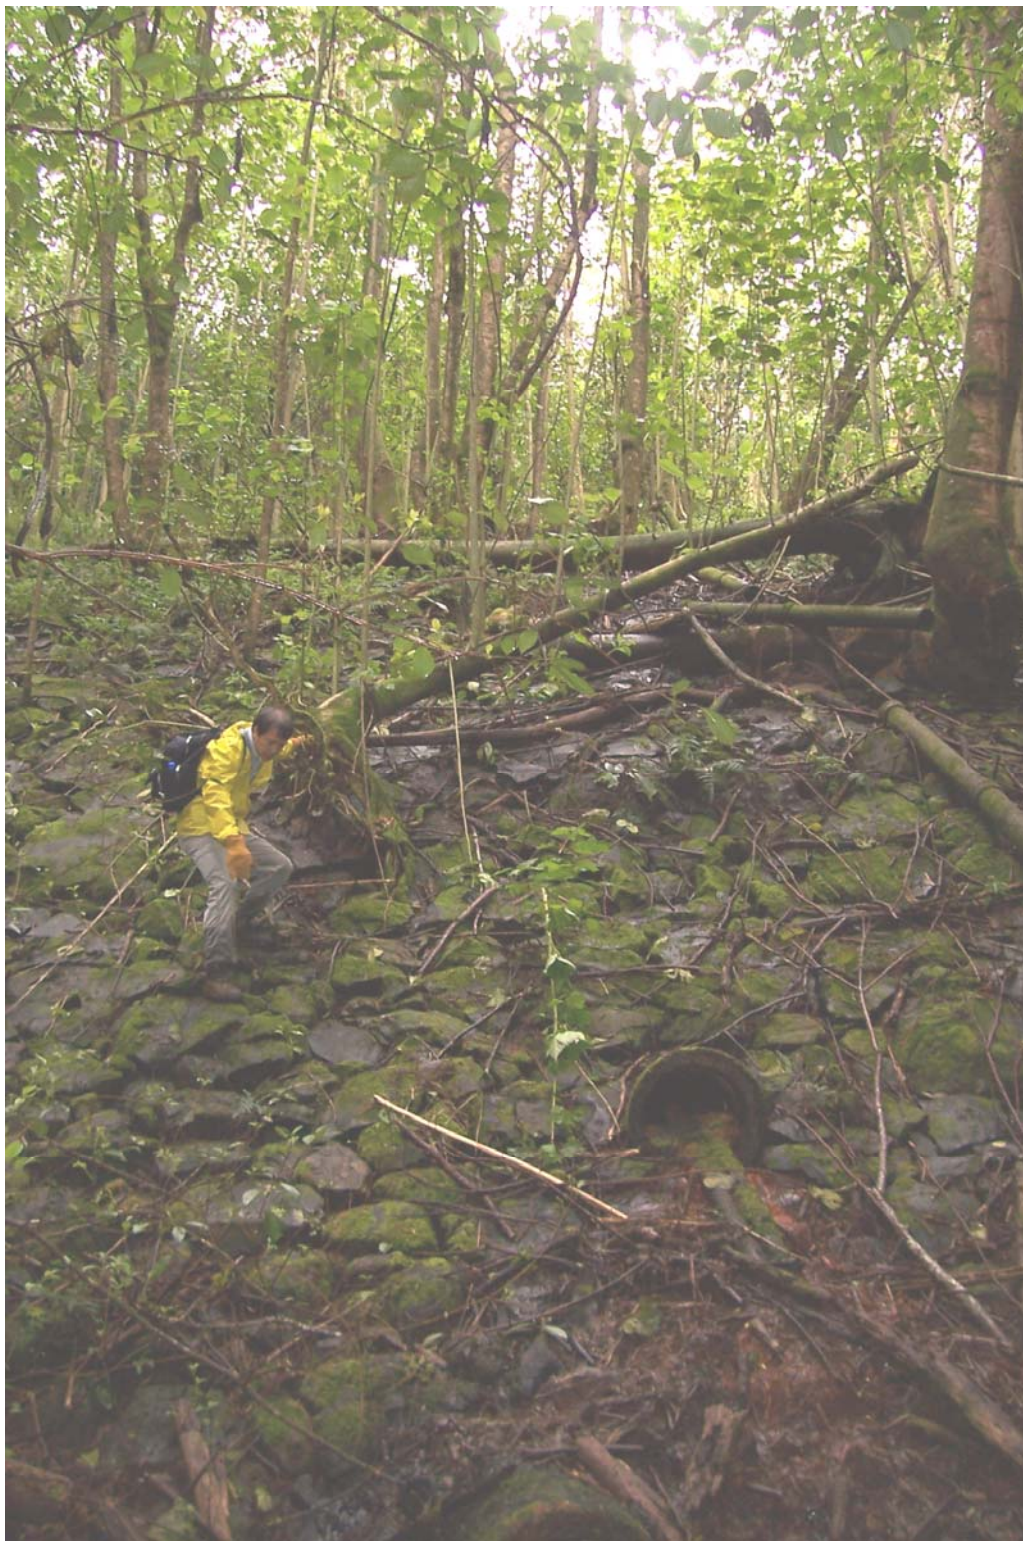
Seep Spot Number 2☐ Green Vegetation x Wet or Muddy Ground ☐ Ponding Water ☐ Not Visible ☐ None ObservedX Flowing, Description: seepage emerging through "rockfill" toe at downstream toeWater Clarity: x Clear ☐ Some particles ☐ Muddy ☐ Other: _____

Photo of D/S slope, rock fill toe drain, and horizontal drain pipes.

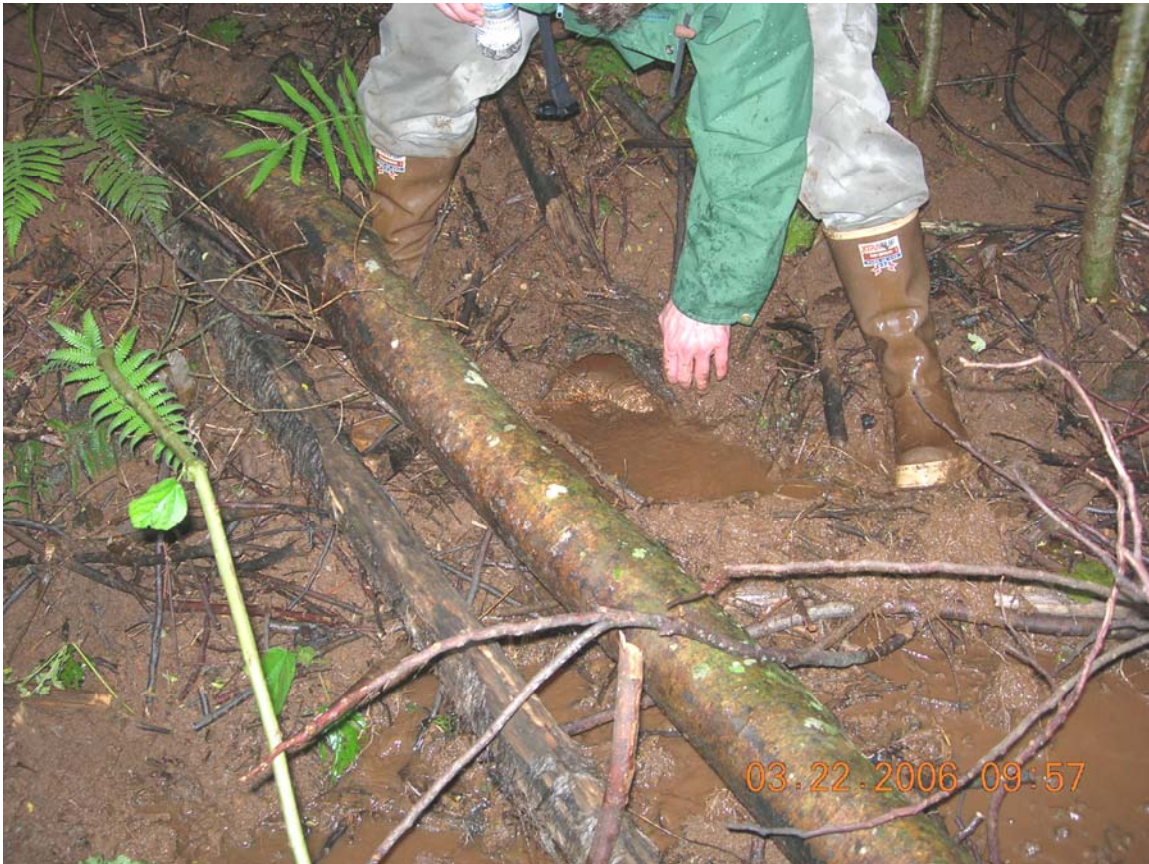
Photo of horizontal drain pipe and flow (seepage) from drain pipe.

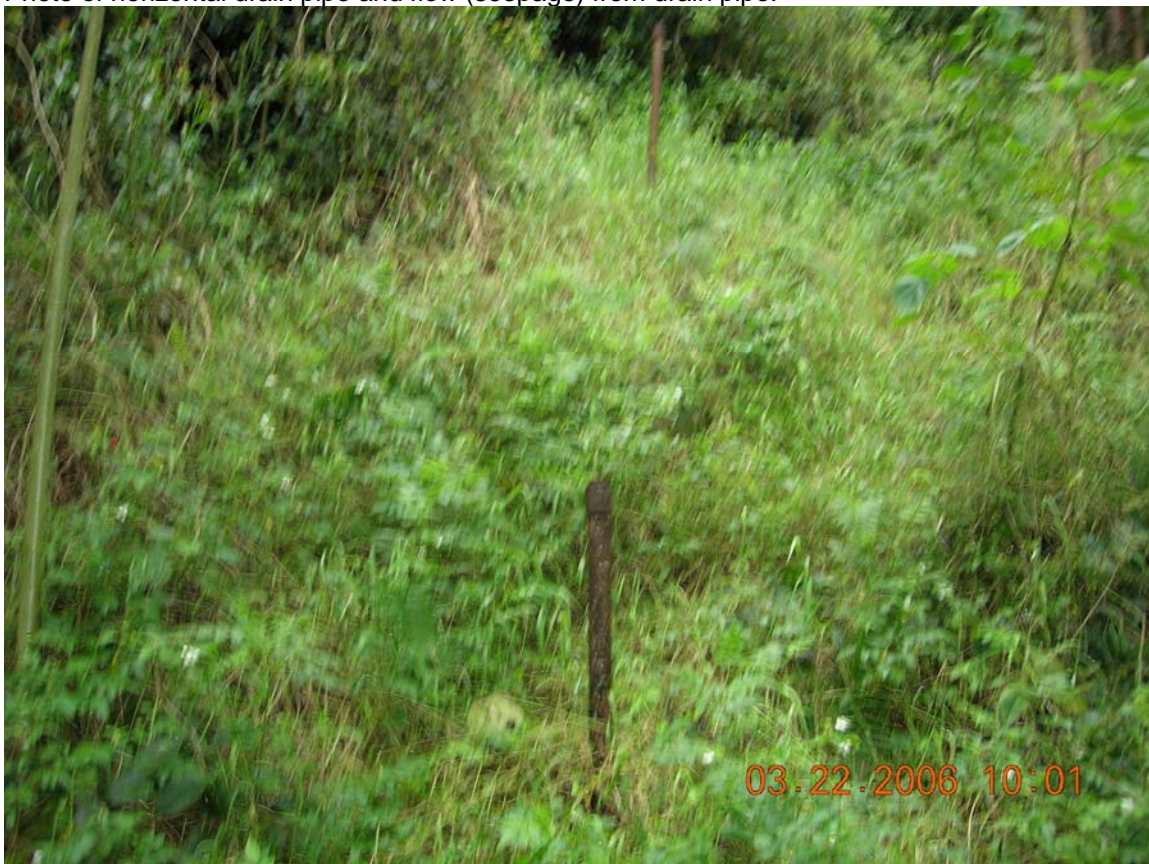
Photo of two vertical metal standpipes on D/S slope. Standpipes appear to be possible piezometers. Note extensive vegetative growth on D/S slope.

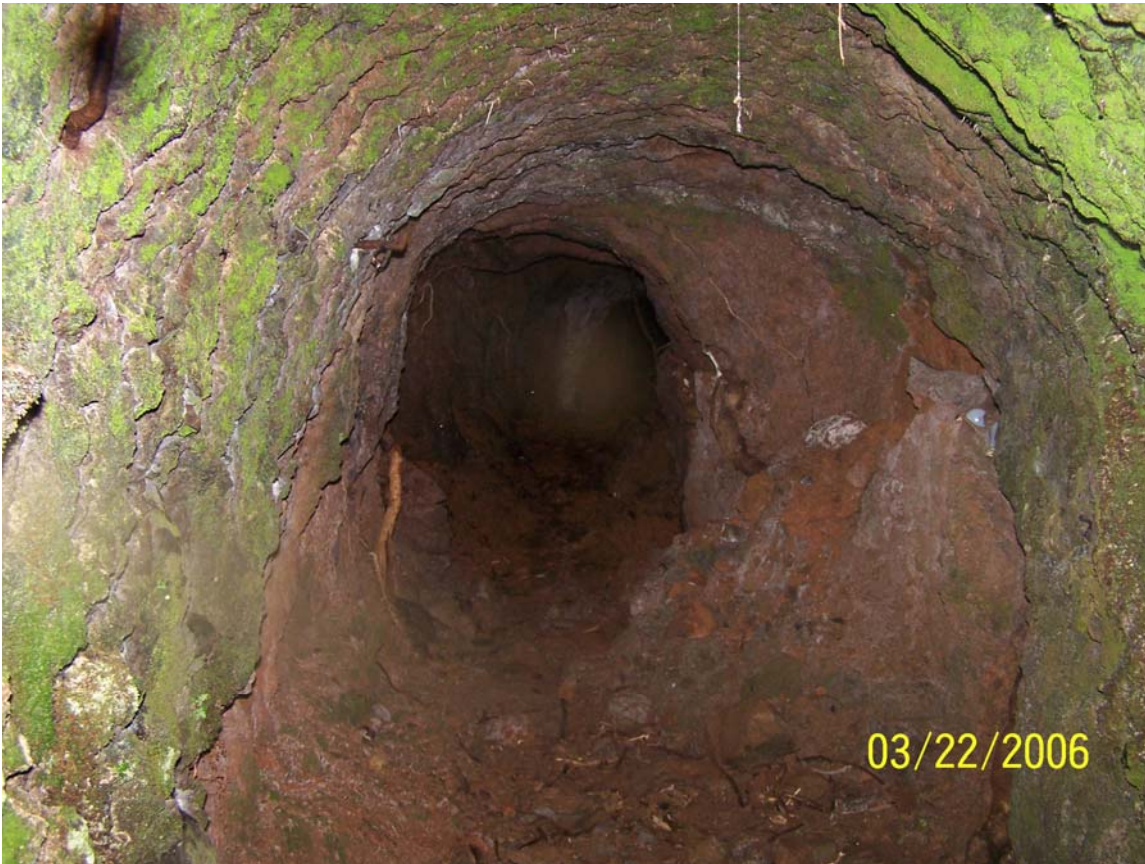
Photo taken of presumed old access tunnel to outlet works gate chamber. Tunnel appears to be unlined.
Photo taken at outlet end of tunnel, which is located D/S of left abutment and near outlet works discharge channel.

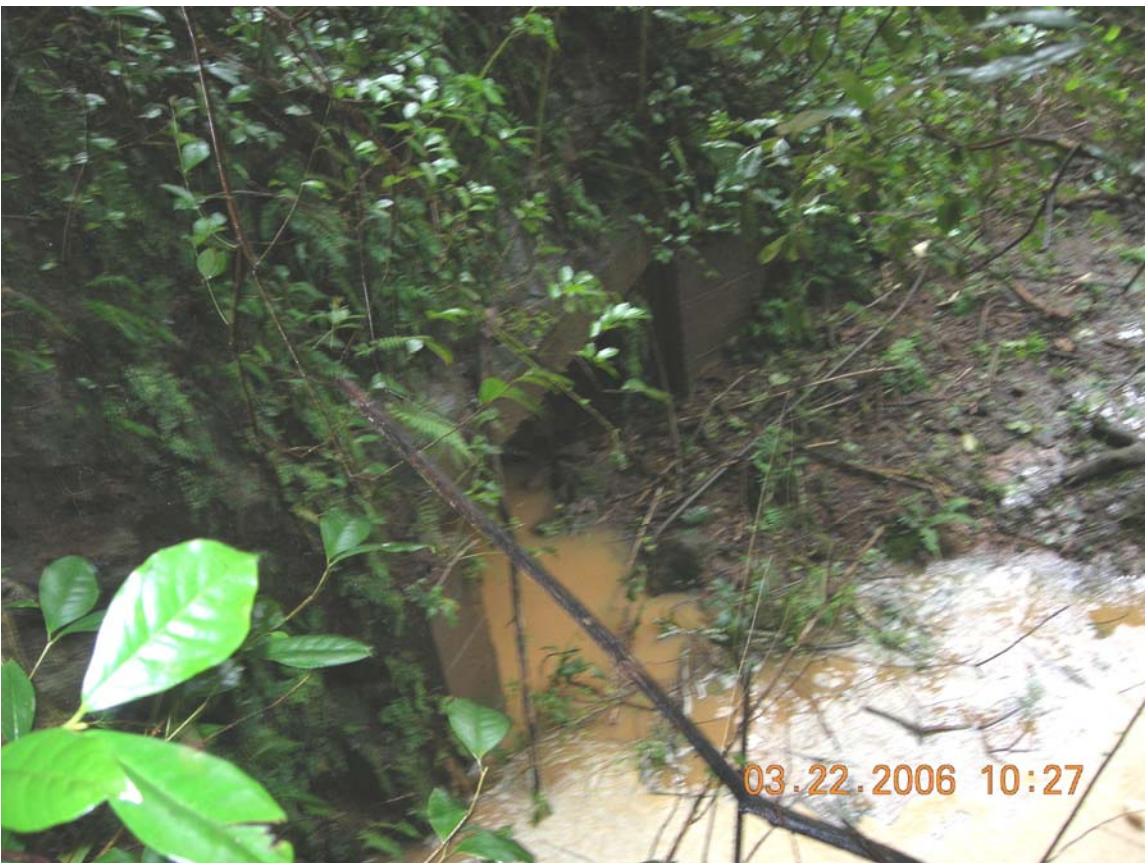
Photo of outlet works concrete conduit and discharge channel, located along left abutment.

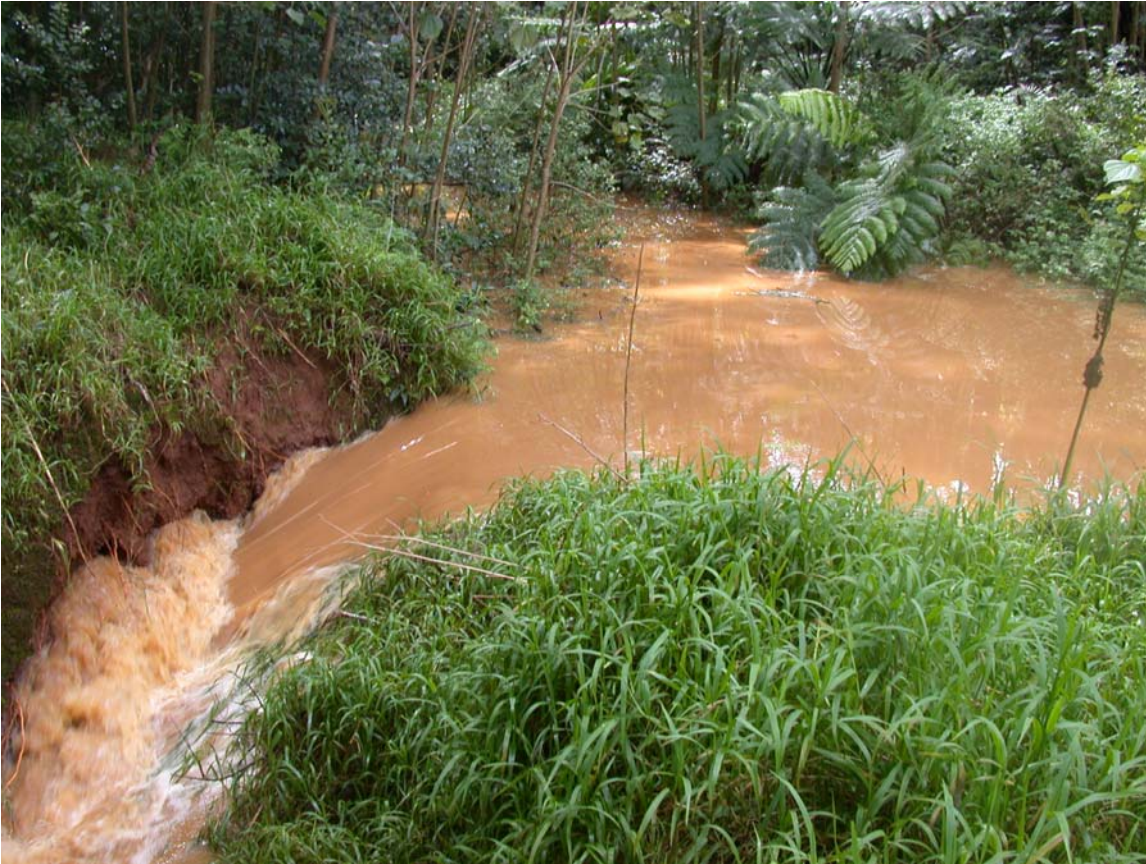
Photo taken of discharge channel, D/S of outlet works conduit. Photo shows location where discharge flows exceeded capacity of channel and overflowed into a side ditch.

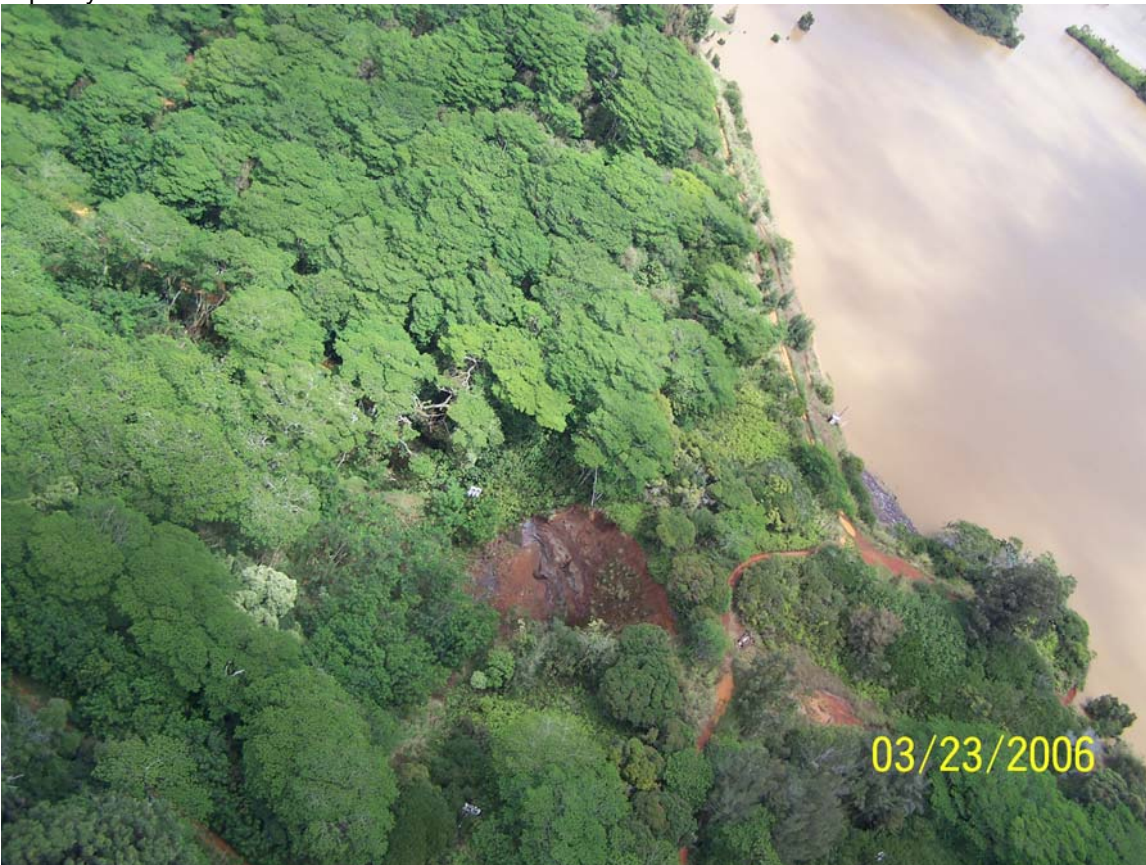
Aerial photo of dam, reservoir, & rock slide area, located along left abutment. Deep "gully" area not visible due to tree growth.

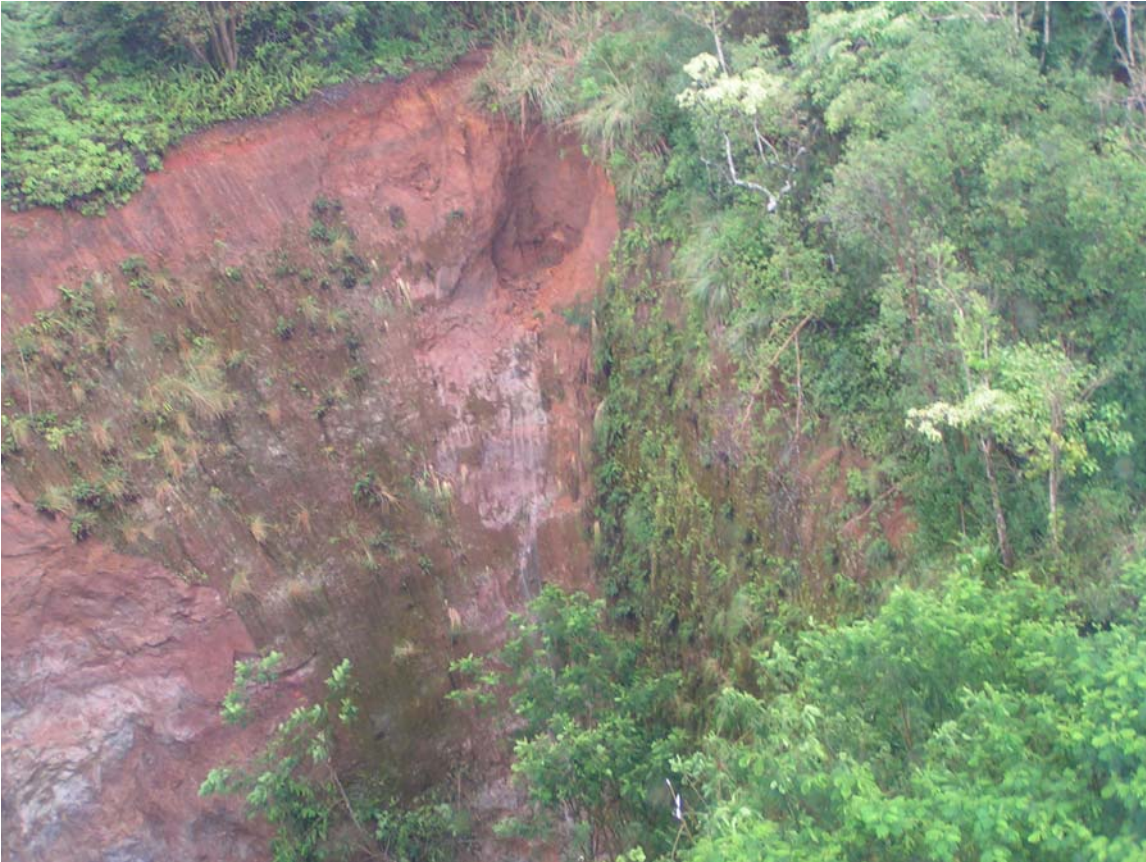
- A large "gully", located in the south abutment and approximately 140 feet from the reservoir, was observed. This "gully" is approximately 130 feet deep and appears to have been quarried. There were at least two recent debris falls in the "gully". A recent notch in the upper right corner of the gully also shows debris fall activity. Water was observed flowing from this notch and down the face of the gully. The amount of flow was estimated to be 20 gpm – 50 gpm. Flow from the notch should be monitored since the source of the flow is not known or if it is related to the reservoir. In addition, a relatively large rock slide, located adjacent to the above gully, was also observed and appears to have been caused by the recent heavy rainfalls. This rock slide does not pose a threat to the safety of the dam. This rock slide area should continue to be monitored.

Aerial Photo of landslide/rock slide area and deep "gully". Photo is a closer view of above aerial photo.

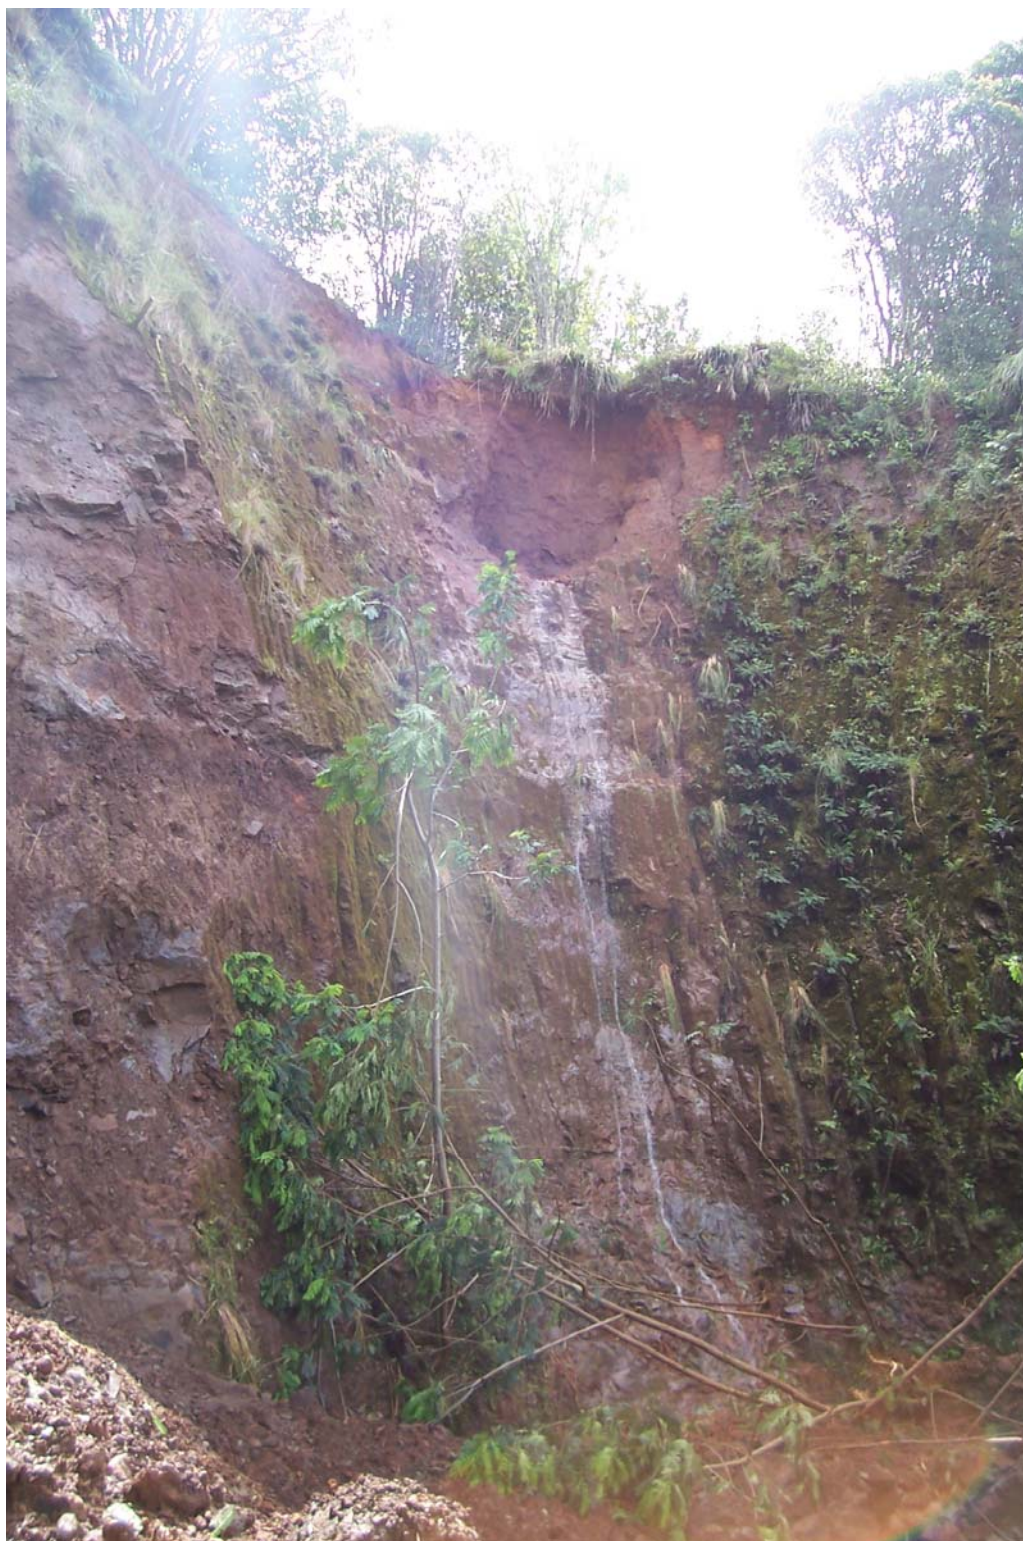
Photo taken of deep "gully"(approx. 130 feet deep) and water flowing from erosion area at top of photo.

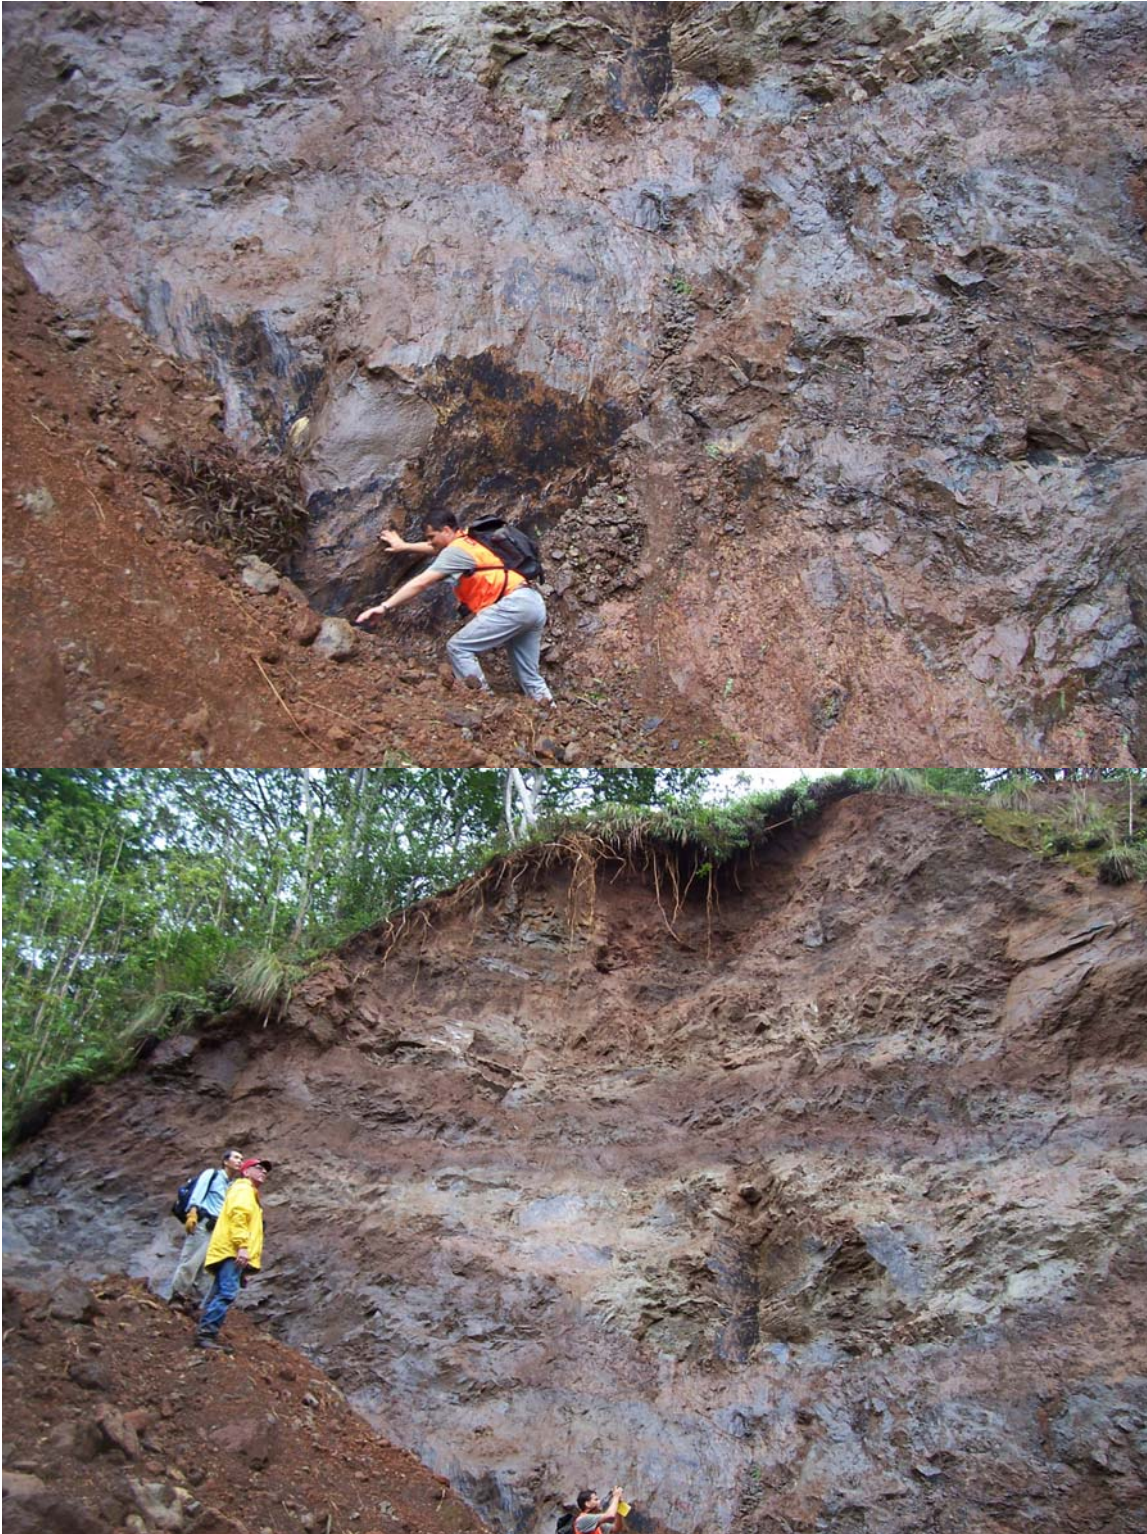
Photo taken of relatively large rock slide area. Photo is a close-up view of rock slide area noted in above aerial photo.

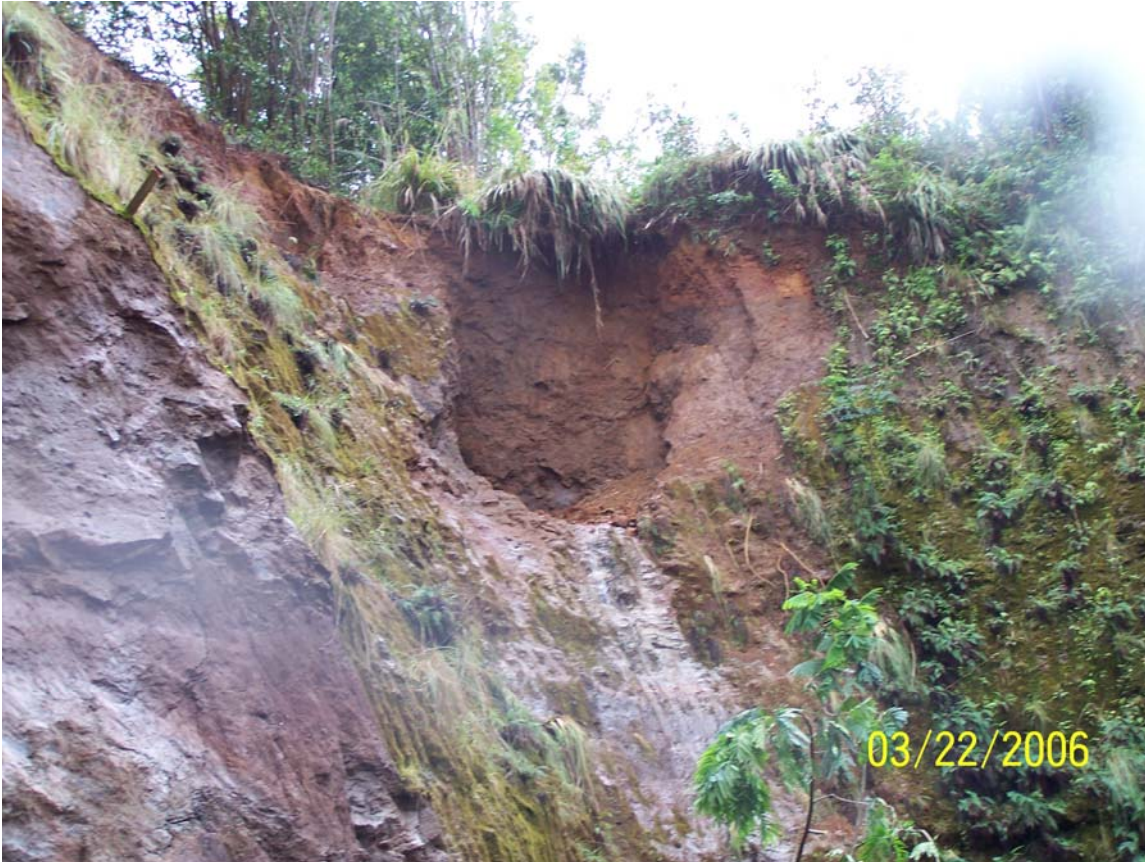
Close-up photo of eroded area near the top of the deep "gully" noted in above photos. Water observed flowing from this area.

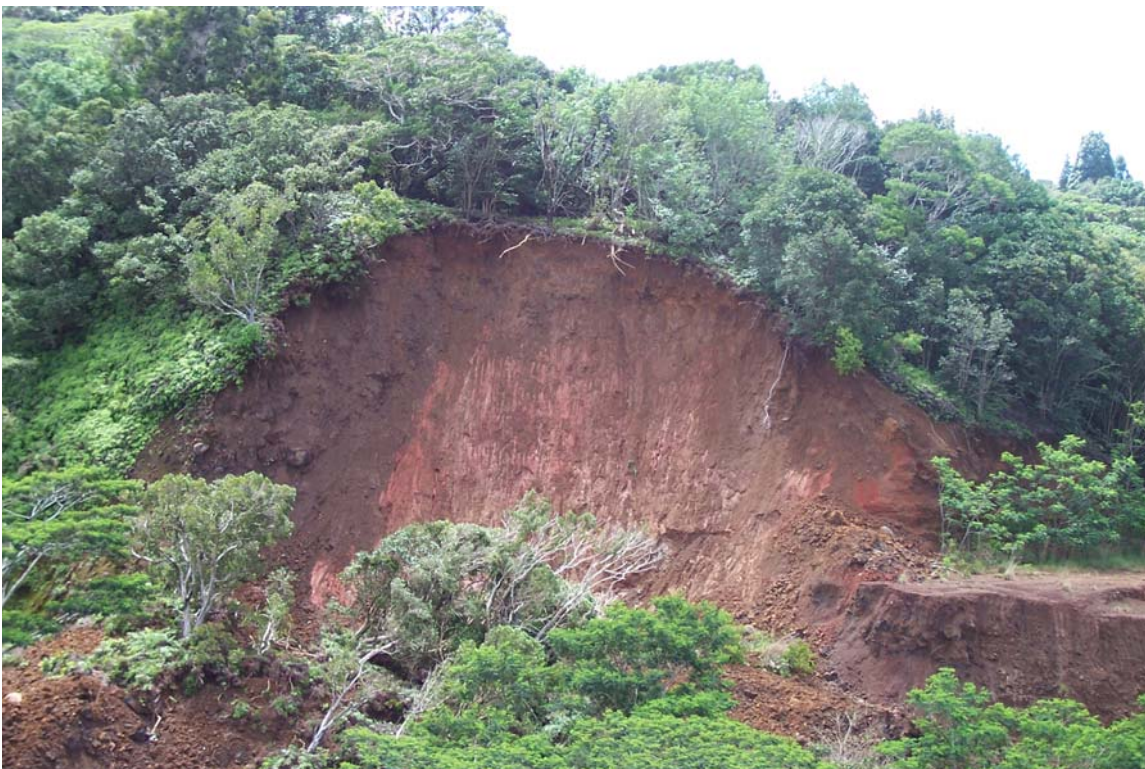
Photo taken of recent landslide, located further D/S of dam and reservoir. Landslide material blocked portion of D/S discharge channel. Note this landslide is further D/S of rock slide noted in above photos.

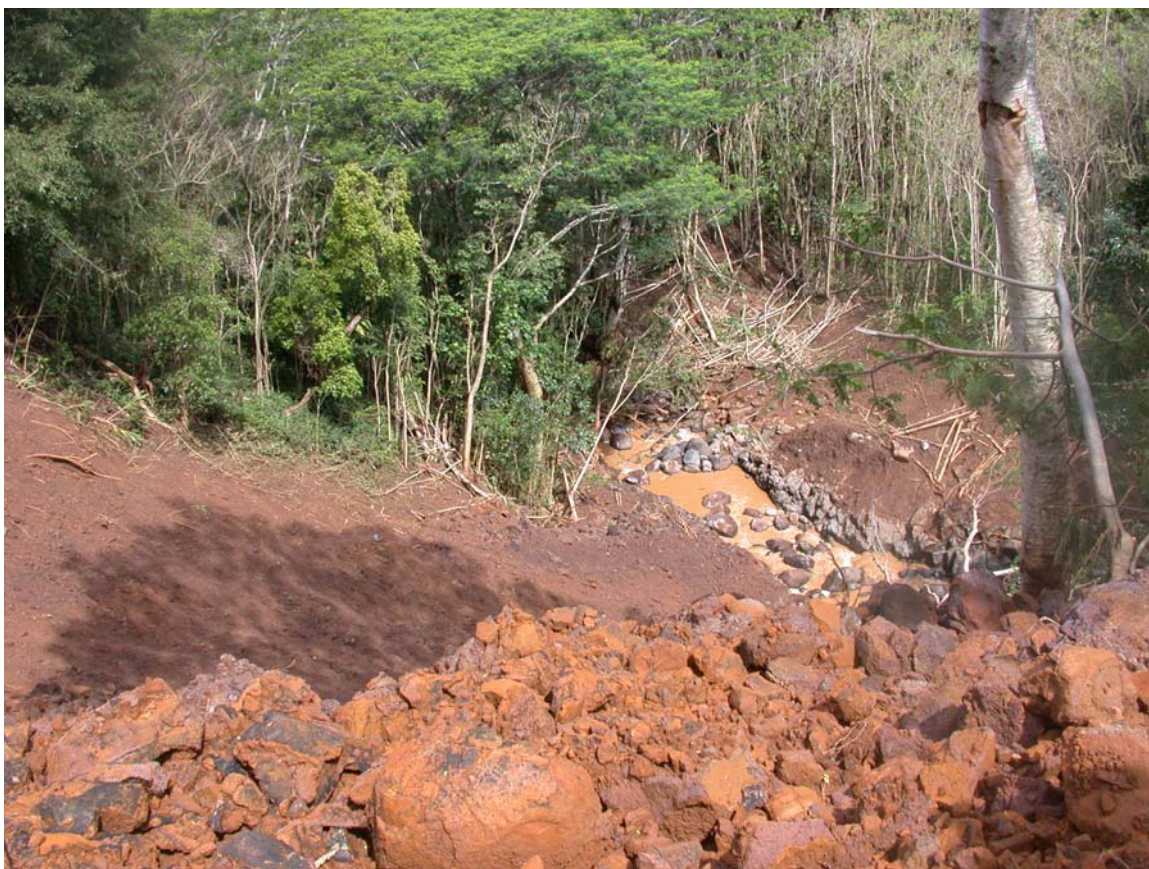
Photo of landslide debris, which blocked D/S discharge channel.

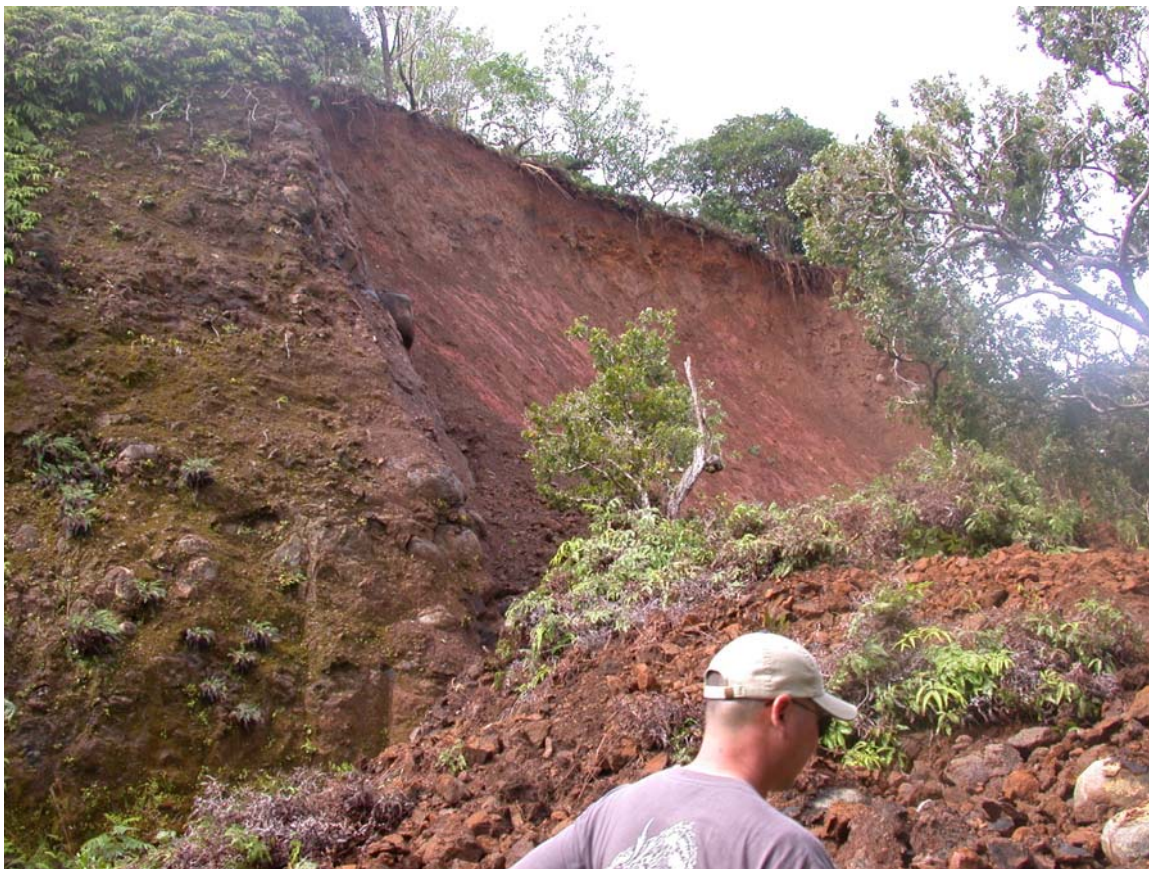
Photo taken of recent landslide area, located further downstream of dam and reservoir.
